LONG CREEK, CENTENNIAL VALLEY, MT
INCISED CHANNEL RESTORATION PILOT PROJECT:
Demonstration of Hardened Riffle Construction
J-Bar-L Ranch 2014

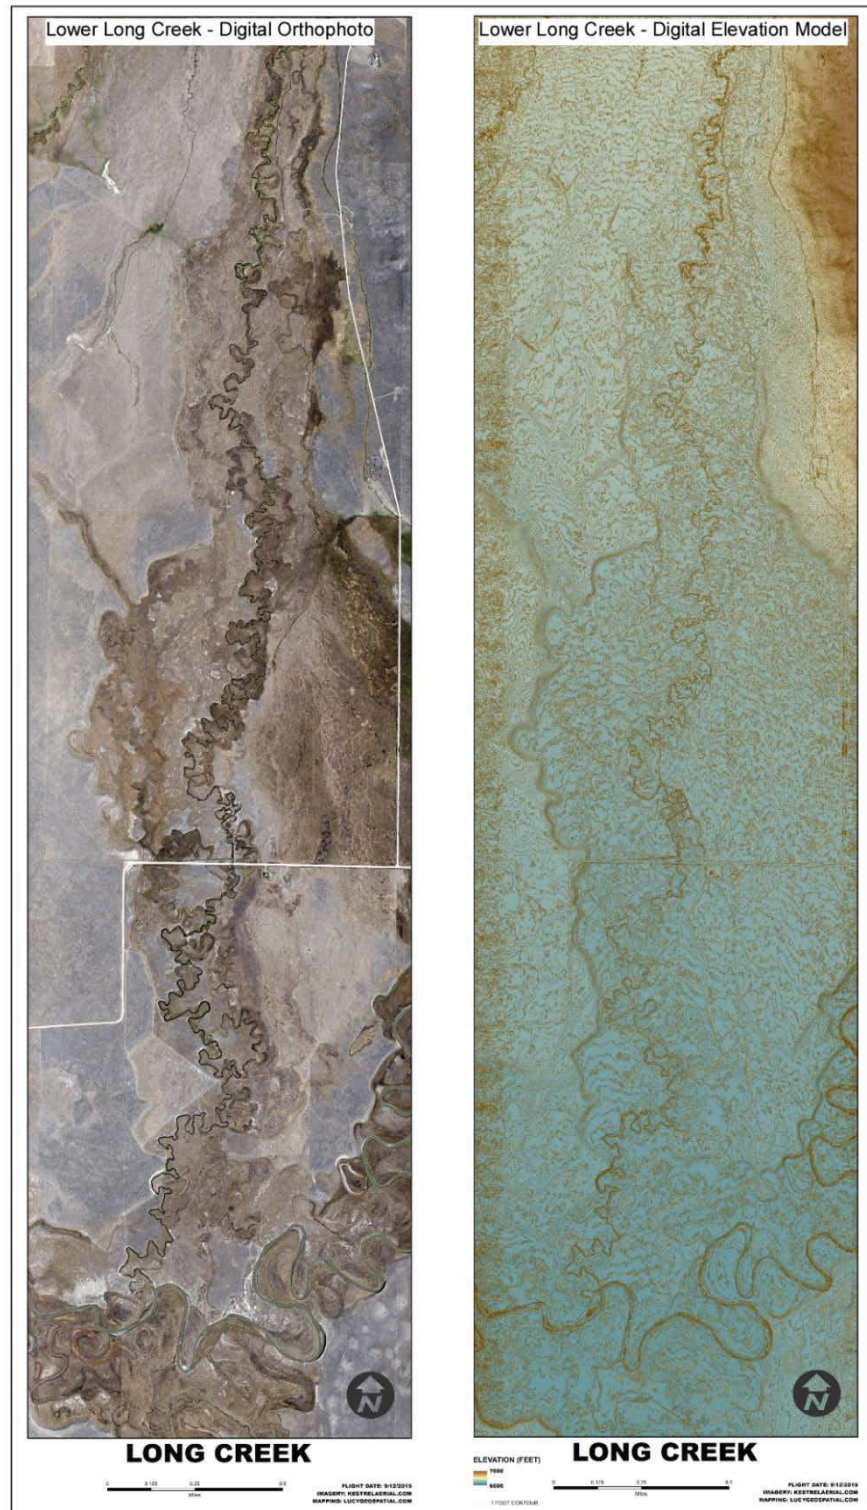
Figure 9. High-resolution orthophoto converted photogrammetrically to a digital elevation model. The elevation model was utilized to create floodplain inundation maps to gain a long-reach understanding of channel condition and to guide design of riffle.

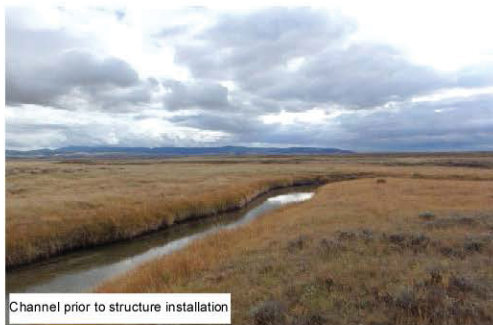
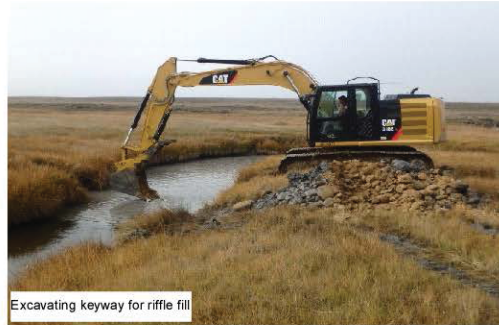
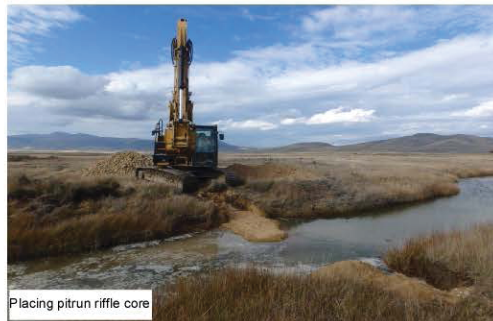
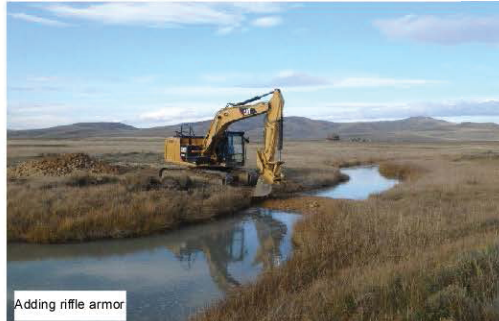
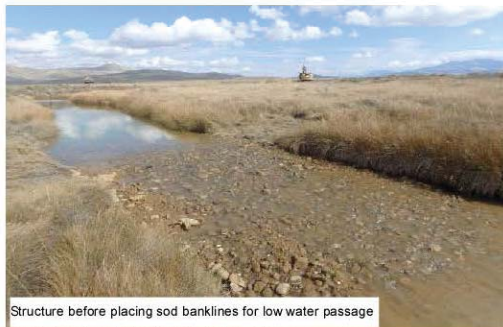
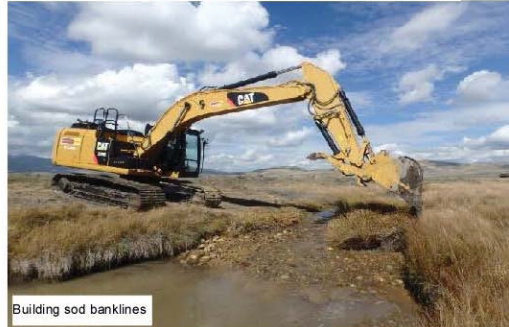
Figure 12. Photo construction sequence of an armored riffle and sod grade control structure.
